PRIMARY RECORD

* Resource Name or #: 13040 Del Monte Drive/Building 45/Leisure World

State of California & The Resources Agency
DEPARTMENT OF PARKS AND RECREATION
DISTRICT RECORD

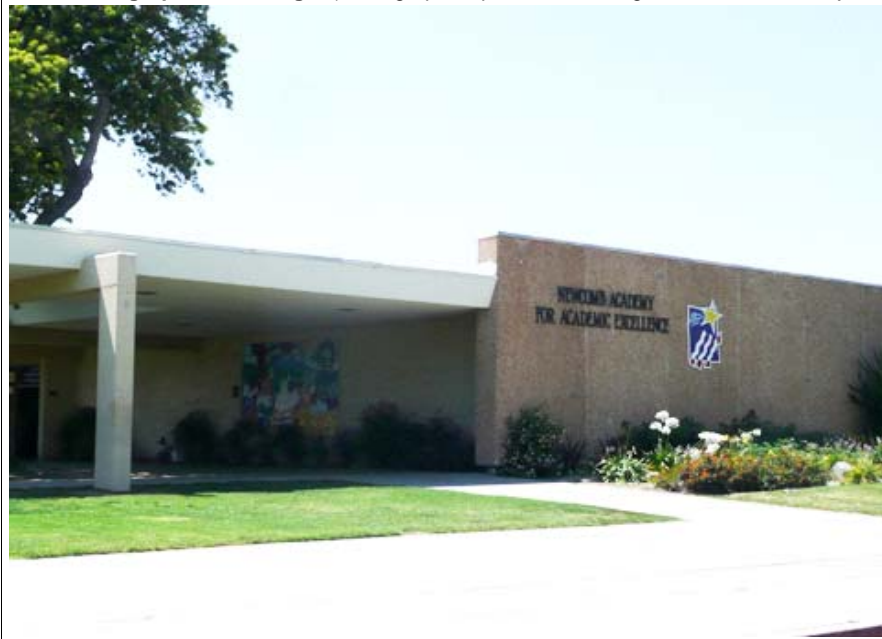
Facing WNW; 6/24/2010; Photo No.

* P3a. Description: (Describe resource and its major elements. Include design, materials, condition, alterations, size, setting, and boundaries.)
The one-story Ranch style school is generally 'U'-shaped in plan with open corridors typical of school buildings from this time period. The flat roof is clad in composition roll. The exterior walls are clad in brick veneer. Fenestration consists of bands of multi-light windows, some of which operate as pivoting units. A mural accents the primary entry corridor. Approximately 12 modern portable buildings are located on the grounds of the school. Though the school individually possesses sufficient integrity to be considered eligible for listing in the NRHP and the CRHR, the school does not meet the NRHP and CRHR eligibility criteria for the reasons identified on the district record prepared for this subdivision; therefore the building does not contribute to a historic district and is not individually eligible for listing in the NRHP and the CRHR.

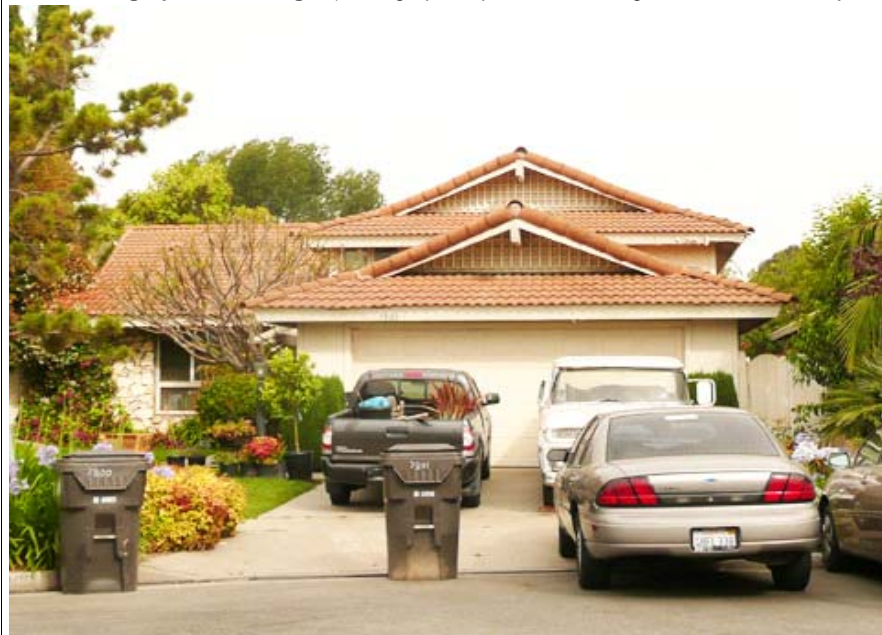
View of a common Ranch style building in this district.

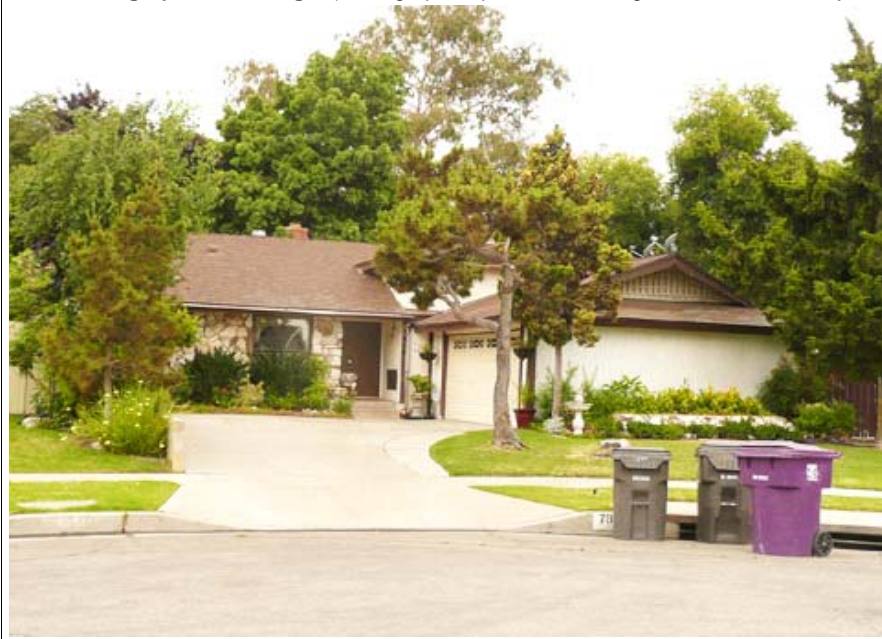
* P3a. Description: (Describe resource and its major elements. Include design, materials, condition, alterations, size, setting, and boundaries.)
The 1 1/2-story Ranch style building is irregular in plan. The gable on hip roof, with flared gables and boxed eaves, is clad in composition shingles. The gables are accented with false timbering. A brick chimney is located on the west face of the roof. The exterior walls are clad in vertical wood siding, smooth textured stucco, and stone veneer. The windows have been replaced with modern anodized aluminum units. The primary entrance is raised, recessed, and the entry door has square detailing. An attached 2-car garage projects from the northern end of the east face of the building, and is accented with a stone planter. The building does not meet the NRHP and CRHR eligibility criteria for the reasons identified on the district record prepared for this subdivision; therefore the building does not contribute to a historic district and is not individually eligible for listing in the NRHP and the CRHR.

Facing southwest; 6/15/2010; Photo No. P1040429.jpg

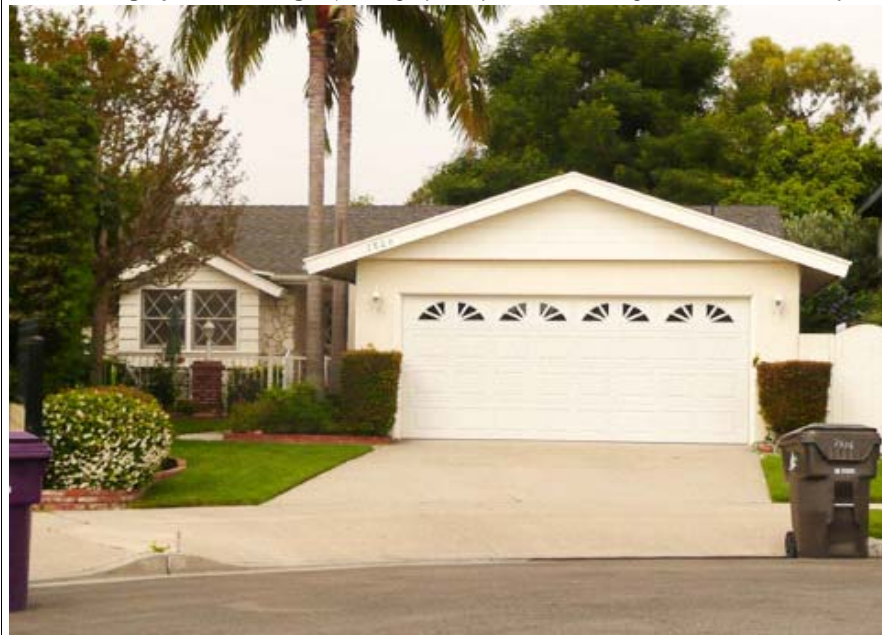
* P3a. Description: (Describe resource and its major elements. Include design, materials, condition, alterations, size, setting, and boundaries.)
The one-story Ranch style house is 'L'-shaped in plan. The cross gabled roof is clad in composition shingles. The exterior walls are clad in smooth textured stucco. The northern gable and the projecting bay on the southern bay are clad in horizontal wood siding, and the southern bay is clad in stone veneer. The diamond-paned wood sash windows appear to be original. The primary entryway is recessed, is at grade, and has a wood with diamond-pane door. A two-car garage is located in the northern bay. A small metal fence with low brick piers creates a courtyard. Landscaping includes brick planters and mature palm trees. The building does not meet the NRHP and CRHR eligibility criteria for the reasons identified on the district record prepared for this subdivision; therefore the building does not contribute to a historic district and is not individually eligible for listing in the NRHP and the CRHR.

Facing southwest; 6/15/2010; Photo No.
P1040431.jpg

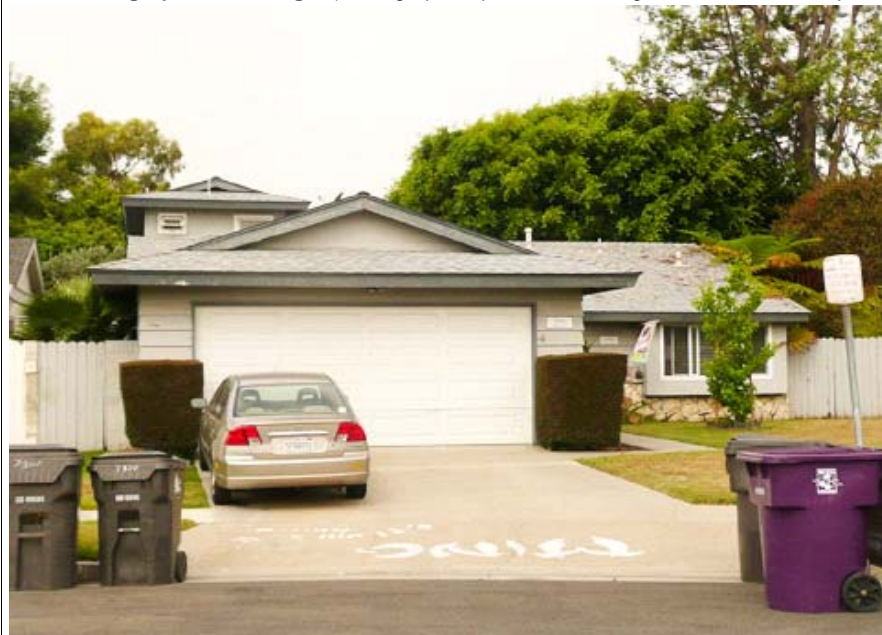
* P3a. Description: (Describe resource and its major elements. Include design, materials, condition, alterations, size, setting, and boundaries.)
The 1 1/2-story Ranch style building is irregular in plan. The gable on hip roof, with flared eaves, is clad in composition shingles. The exterior walls are clad in horizontal wood siding with stone veneer to the water line. The windows have been replaced with vinyl sliding and fixed pane units. The primary entryway is recessed. Additional details are not discernable from the public right of way. The building does not meet the NRHP and CRHR eligibility criteria for the reasons identified on the district record prepared for this subdivision; therefore the building does not contribute to a historic district and is not individually eligible for listing in the NRHP and the CRHR.

Facing WSW; 6/15/2010; Photo No.

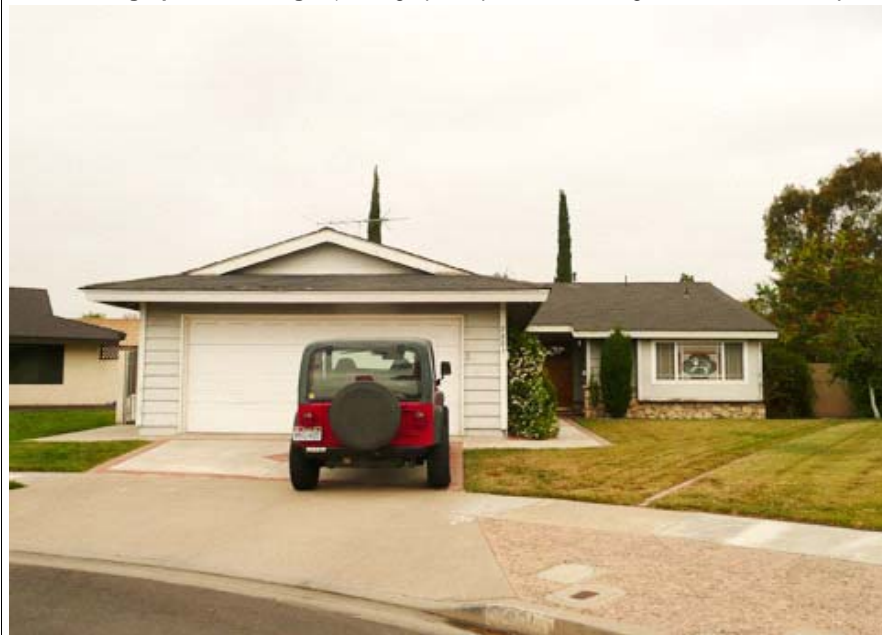
* P3a. Description: (Describe resource and its major elements. Include design, materials, condition, alterations, size, setting, and boundaries.)
The one-story Ranch style building is 'L'-shaped in plan. The gable on hip roof is clad in composition shingles. The exterior walls are clad in horizontal wood siding with stone veneer to the water line. The projecting bay on the northern bay is clad in smooth textured stucco. The windows have been replaced with vinyl sliding and fixed pane units. The primary entryway is raised, recessed, and accessed via a cast concrete porch clad in brick. The primary entry door is a modern door with half-lunette light. The building does not meet the NRHP and CRHR eligibility criteria for the reasons identified on the district record prepared for this subdivision; therefore the building does not contribute to a historic district and is not individually eligible for listing in the NRHP and the CRHR.

Facing west; 6/15/2010; Photo No.

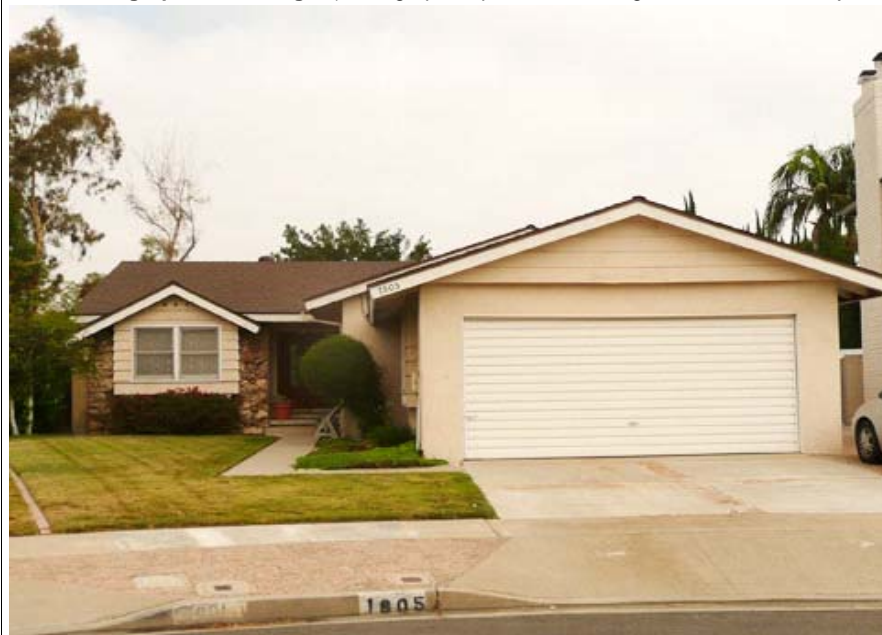
* P3a. Description: (Describe resource and its major elements. Include design, materials, condition, alterations, size, setting, and boundaries.)
The one-story Ranch style building is 'L'-shaped in plan. The cross gable roof, with boxed eaves, is clad in composition shingles. The exterior walls are clad in smooth textured stucco and stone veneer. The projecting bays of the southern bay and the south side of the northern bay are clad in horizontal wood siding, and the projecting bay on the southern bay is further accented with a rookery. The one over one wood sash windows appear to be original. The primary entrance is raised, recessed, and accessed via a cast concrete porch. A two-car garage is located in the northern bay. The building does not meet the NRHP and CRHR eligibility criteria for the reasons identified on the district record prepared for this subdivision; therefore the building does not contribute to a historic district and is not individually eligible for listing in the NRHP and the CRHR.

facing northwest; 6/15/2010; Photo No.

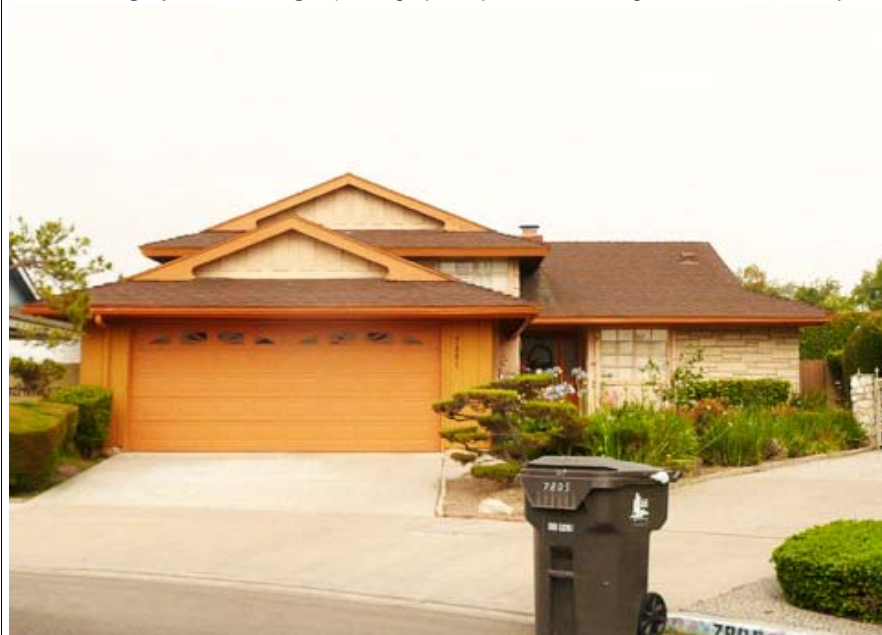
* P3a. Description: (Describe resource and its major elements. Include design, materials, condition, alterations, size, setting, and boundaries.)
The 1 1/2-story Ranch style building is irregular in plan. The cross gable on hip roof, with flared and boxed eaves, is clad in composition shingles. The front facing gables are accented with tapered barge board and false timbering. The exterior walls are clad in stone veneer and horizontal wood siding. The multi-light wood casement windows appear to be original. The primary entryway is raised, recessed, and accessed via a cast concrete porch. A two-car garage projects from the southern end of the primary (eastern) facade, and is accented with vertical wood siding. A brick chimney is located on the west face of the roof. Landscaping includes topiaries. The building does not meet the NRHP and CRHR eligibility criteria for the reasons identified on the district record prepared for this subdivision; therefore the building does not contribute to a historic district and is not individually eligible for listing in the NRHP and the CRHR.

Facing west; 6/15/2010; Photo No.

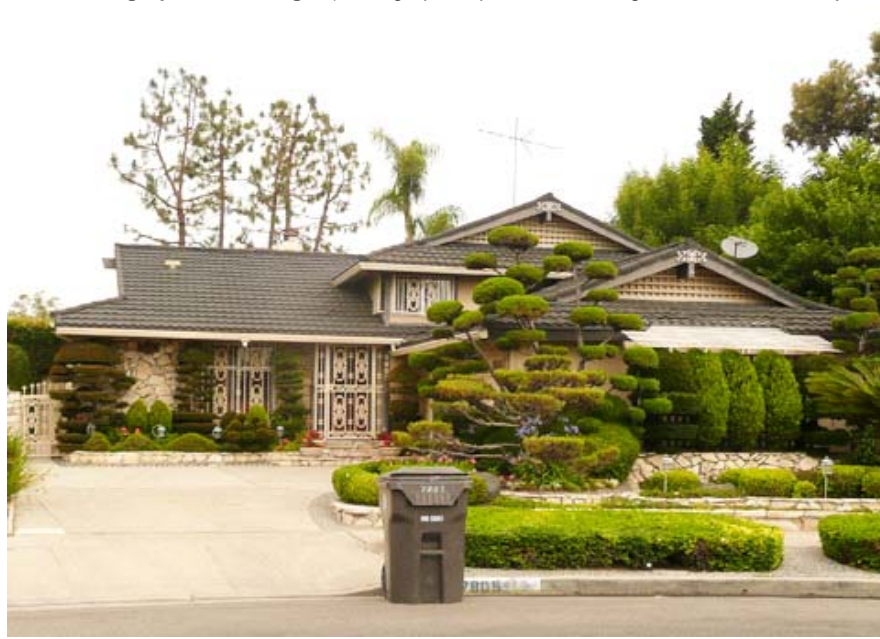
* P3a. Description: (Describe resource and its major elements. Include design, materials, condition, alterations, size, setting, and boundaries.)
The 1 1/2-story Ranch style building is 'L'-shaped in plan. The cross gable on hip roof, with flared and boxed eaves and gables, is clad in modern tile. The gables are accented with lattice veneer and false beams at the apex of the gable. A brick chimney is located on the south face of the roof. The exterior walls are clad in stone veneer, vertical wood siding, and rough textured stucco. The aluminum sliding and fixed pane windows appear to be original. The primary entry is recessed, and details are not discernable from the public right of way. A two-car garage projects from the northerly bay of the primary (southeast) facade. Landscaping includes mature topiaries and stone planters. The building does not meet the NRHP and CRHR eligibility criteria for the reasons identified on the district record prepared for this subdivision; therefore the building does not contribute to a historic district and is not individually eligible for listing in the NRHP and the CRHR.

Facing northwest; 6/15/2010; Photo No.
P1040435.jpg

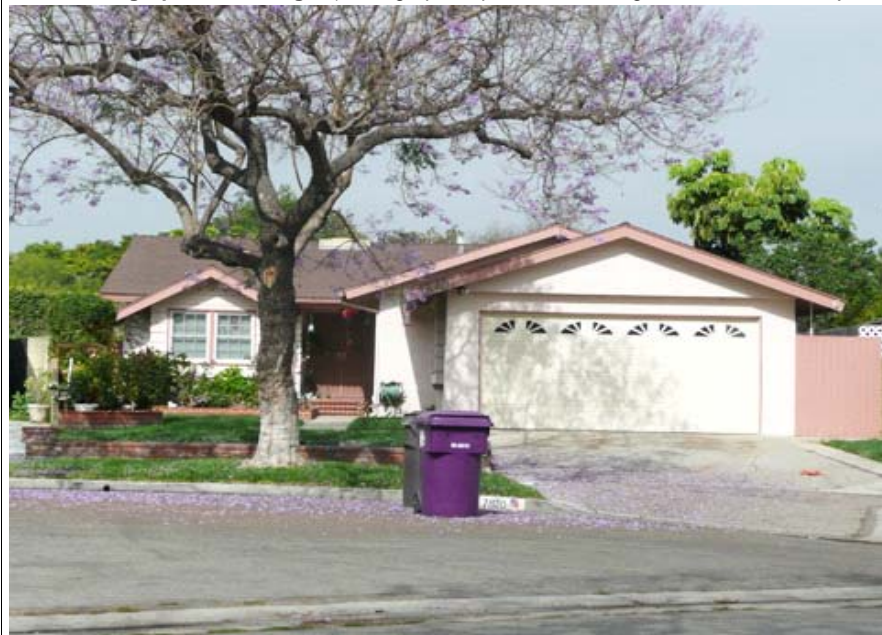
* P3a. Description: (Describe resource and its major elements. Include design, materials, condition, alterations, size, setting, and boundaries.)
The one-story Ranch style building is generally 'L'-shaped in plan. The cross gabled roof, with boxed eaves, is clad in composition shingles. A bubble skylight is centrally located on the east face of the roof. The eastern dormer and projecting bays located on the east face of the southern bay and the southern face of the northern bay are clad in horizontal wood siding. The windows have been replaced with vinyl sash units, and are accented with wood surrounds. The primary entrance is raised, recessed, and accessed via a brick clad porch. A two-car garage is located in the northern bay. The building does not meet the NRHP and CRHR eligibility criteria for the reasons identified on the district record prepared for this subdivision; therefore the building does not contribute to a historic district and is not individually eligible for listing in the NRHP and the CRHR.

Facing west; 6/15/2010; Photo No.

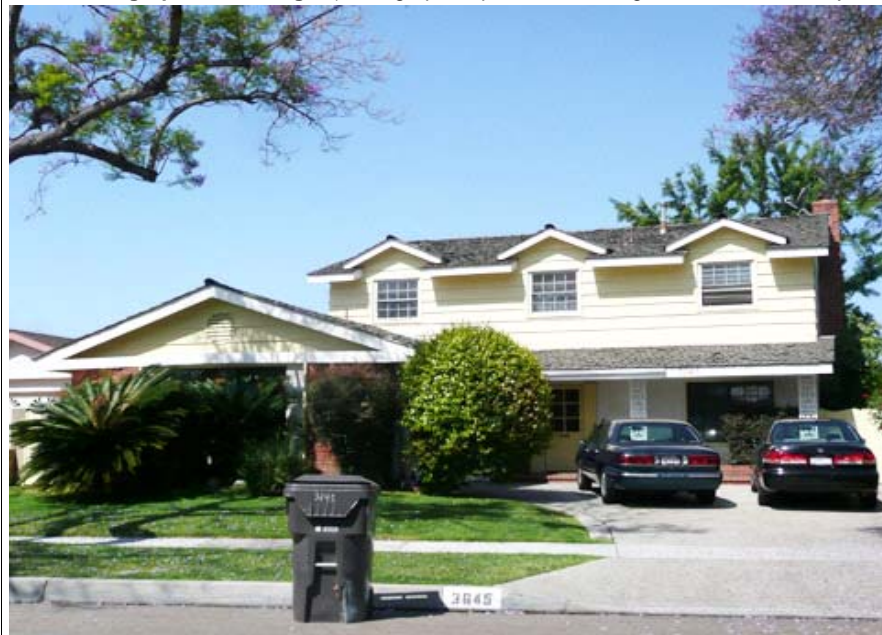
* P3a. Description: (Describe resource and its major elements. Include design, materials, condition, alterations, size, setting, and boundaries.)
The 1 1/2-story Ranch style building is 'L'-shaped in plan. The cross gabled roof, with boxed eaves, is clad in wood shingles. A brick chimney is located on the north elevation. The exterior walls are clad in horizontal wood siding on the upper floor, and smooth textured stucco on the lower floor. The eight-over-eight wood sash windows on the upper floor appear to be original, and the windows on the ground floor have been replaced with modern anodized aluminum sash units. The primary entrance is raised, and is accessed via a brick clad covered porch. The porch pent roof spans the north bay of the primary (eastern) façade, and is supported by decorative metal columns. An attached two-car garage projects from the southern end of the primary (eastern) façade. The east façade of the garage is accented with brick veneer, and a band board accents the front-facing gable. A window is also located on the east façade of the garage, but details are obscured by vegetation. The building does not meet the NRHP and CRHR eligibility criteria for the reasons identified on the district record prepared for this subdivision; therefore the building does not contribute to a historic district and is not individually eligible for listing in the NRHP and the CRHR.

Facing west; 6/14/2010; Photo No.

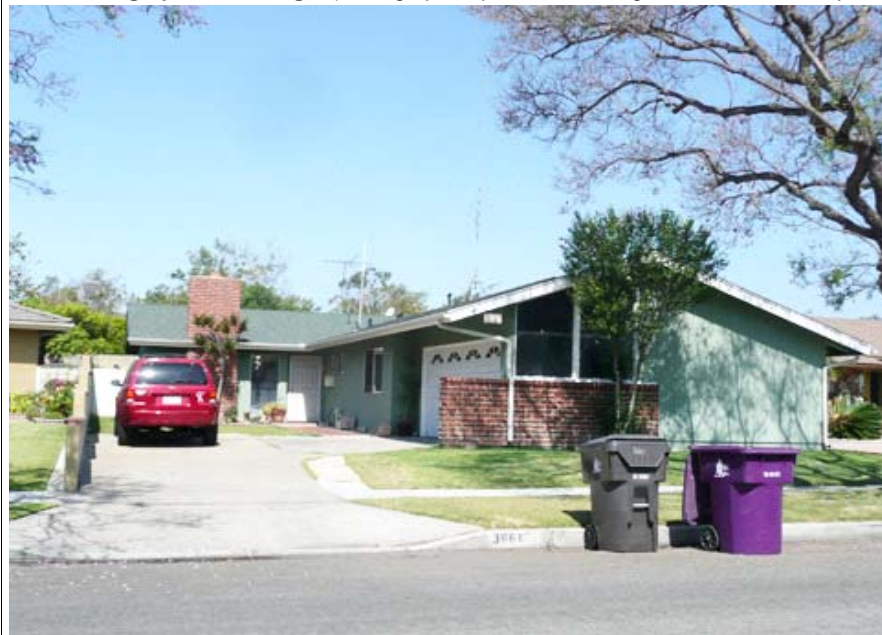
* P3a. Description: (Describe resource and its major elements. Include design, materials, condition, alterations, size, setting, and boundaries.)
The one-story Ranch style building is 'L'-shaped in plan. The cross gabled roof, with boxed eaves, is clad in composition shingles. The exterior walls are clad in smooth textured stucco and vertical wood siding. A brick chimney, with weeping mortar, is prominently located on the southern bay of the primary (east) façade. An attached two-car garage projects from the northern end of the primary façade. The southern end of the east façade of the projecting garage is accented with fixed-pane transom windows, and brick veneer to the water line which extends beyond the building to create a partial private courtyard. The aluminum sliding and fixed-pane windows appear to be original. The primary entrance is at grade. The building does not meet the NRHP and CRHR eligibility criteria for the reasons identified on the district record prepared for this subdivision; therefore the building does not contribute to a historic district and is not individually eligible for listing in the NRHP and the CRHR.

Facing west; 6/15/2010; Photo No.

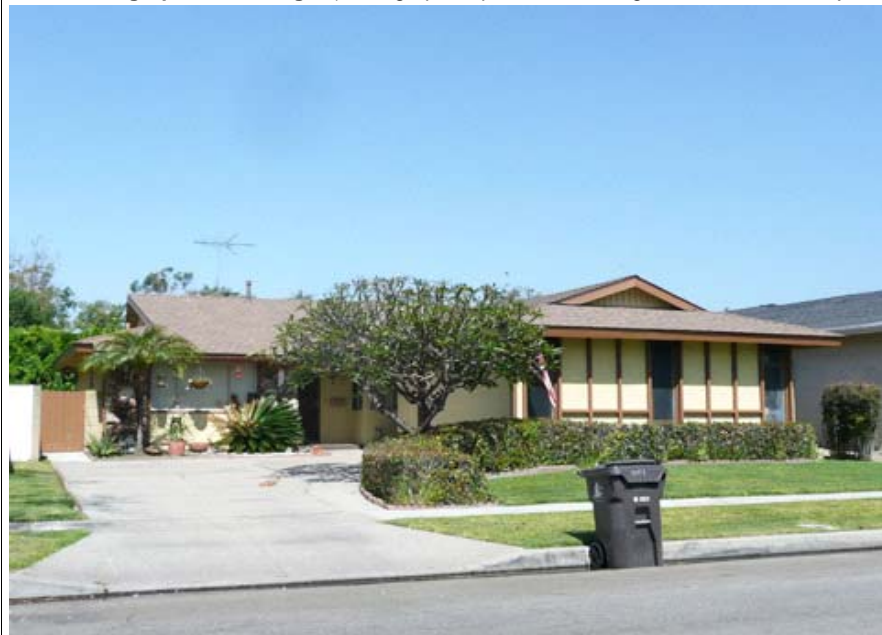
* P3a. Description: (Describe resource and its major elements. Include design, materials, condition, alterations, size, setting, and boundaries.)
The one-story Ranch style building is 'L'-shaped in plan. The cross gable on hip roof, with boxed and flared eaves and gables, is clad in composition shingles. The front-facing gable is accented with lattice-patterned false timbering. The exterior walls are clad in textured stucco with false timbering and stone veneer accents the southerly window on the primary (eastern) façade. The aluminum sliding and fixed-pane windows appear to be original. The primary entrance is raised and recessed. An attached two-car garage projects from the northern end of the primary (eastern) façade. The east façade of the projecting garage is accented with three full-height fixed-pane windows with pebble glass. The building does not meet the NRHP and CRHR eligibility criteria for the reasons identified on the district record prepared for this subdivision; therefore the building does not contribute to a historic district and is not individually eligible for listing in the NRHP and the CRHR.

Facing west; 6/14/2010; Photo No.

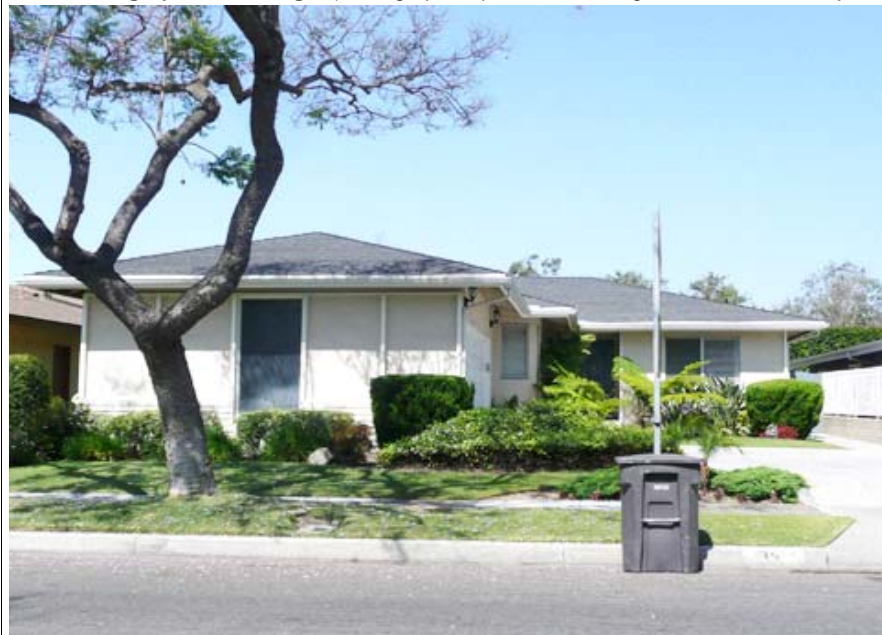
* P3a. Description: (Describe resource and its major elements. Include design, materials, condition, alterations, size, setting, and boundaries.)
The one-story Ranch style building is 'L'-shaped in plan. The cross hipped roof is clad in composition shingles. The exterior walls are clad in smooth textured stucco, with false timbering, and brick veneer to the water line on the east façade of the projecting two-car garage. The east façade of the projecting garage is further accented with a large fixed-pane window with pebble glass and a wood surround. The aluminum sliding windows appear to be original. The primary entrance is raised and recessed. The primary entry door is wood, double-acting, and has decorative square accents. The building does not meet the NRHP and CRHR eligibility criteria for the reasons identified on the district record prepared for this subdivision; therefore the building does not contribute to a historic district and is not individually eligible for listing in the NRHP and the CRHR.

Facing west; 6/14/2010; Photo No.
